The hydrogeology of a moving cut slope and real time modelling of groundwater movement

Abstract

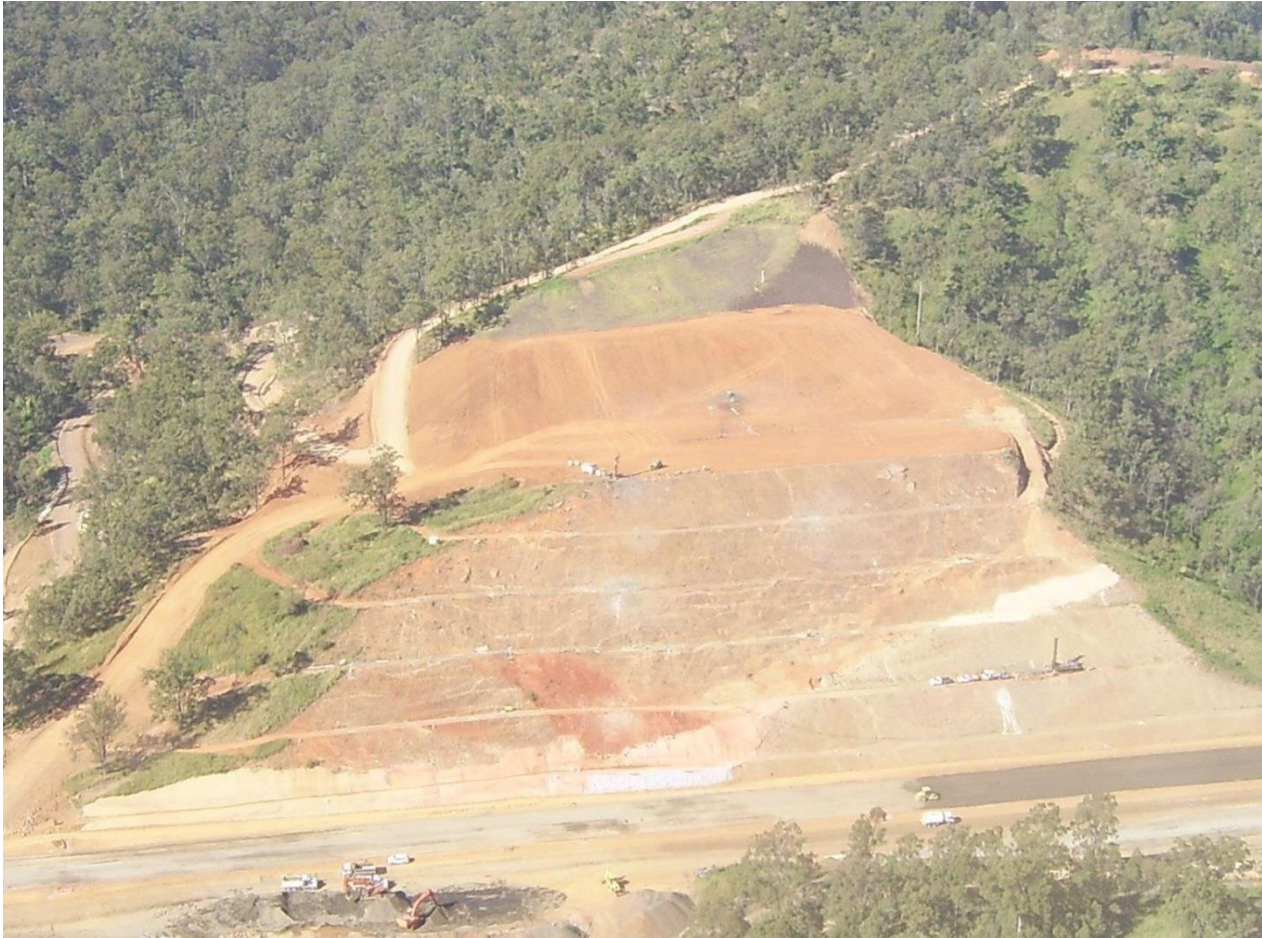
Figure 2 Aerial photograph of cut 3 during removal of the top of the slope and filling of the toe

Figure 1 is a plan of the area showing the roadway and the edge of the cutting. It also shows some of the very large number of boreholes that were drilled in the area. Figure 2 is an aerial photograph of the cut.
